Dams and Dam Failures

Anders Bjarngard, P.E. and Yixing Yuan, Ph.D.

Annual Joint Conference
(Virtual)
November 17, 2020

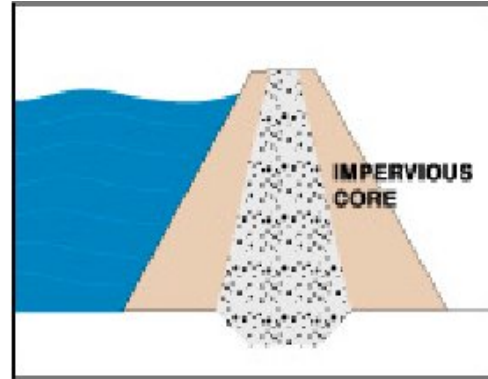
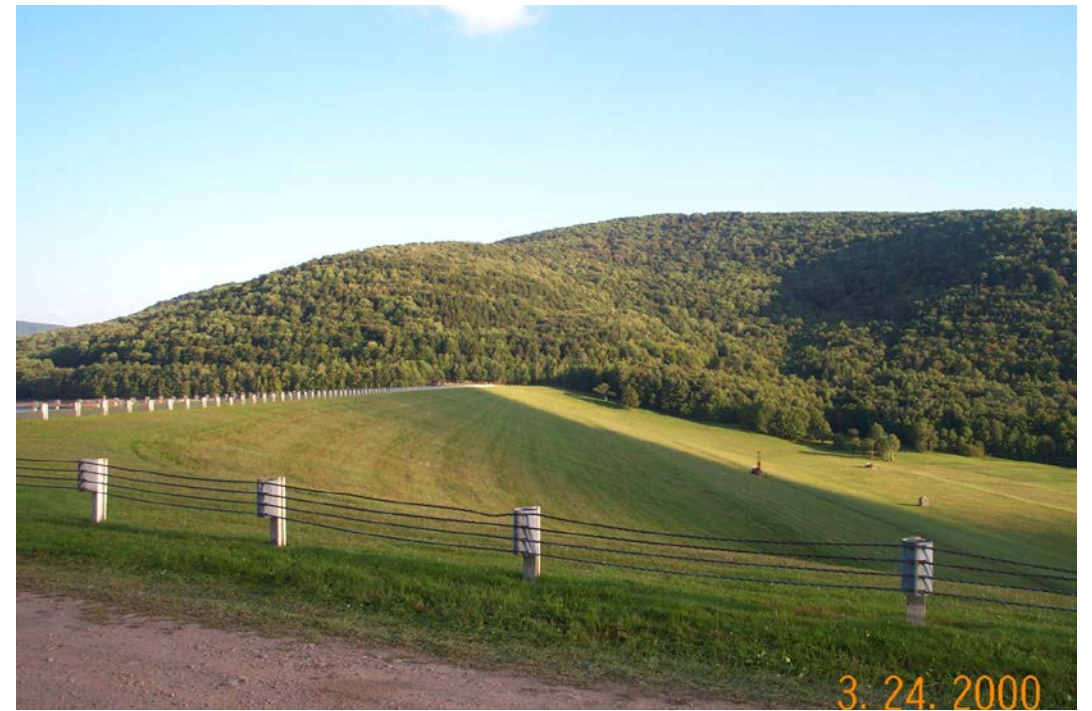
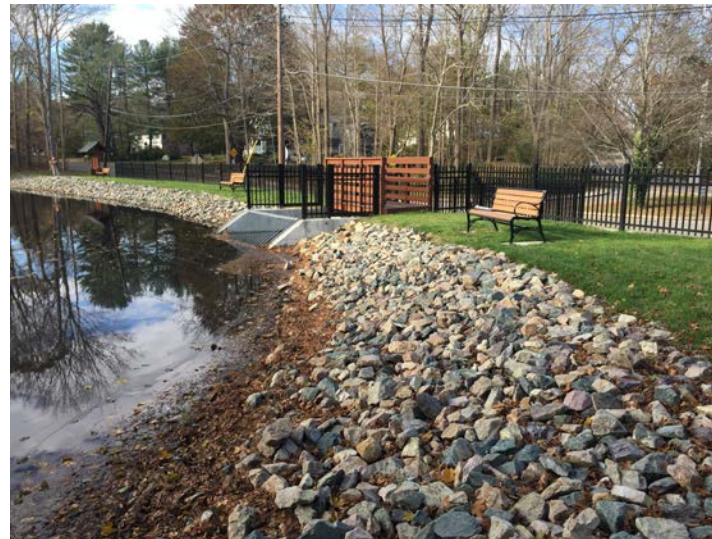
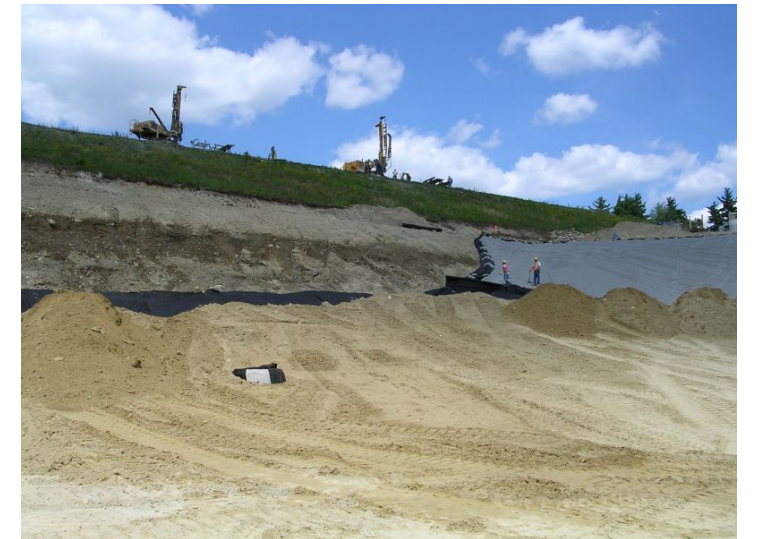
Types of Dams

- **Earthfill (about 90 percent)**

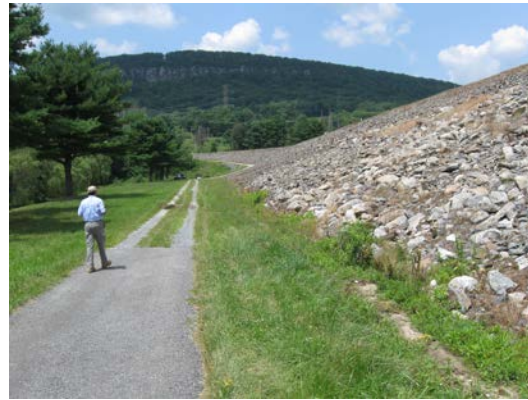
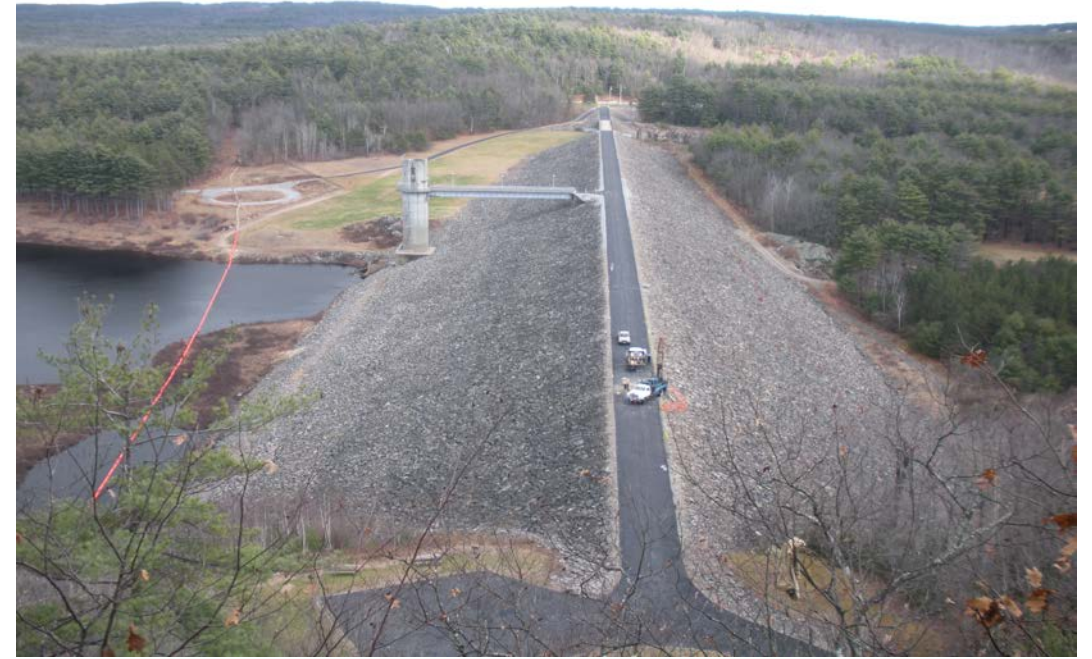
Types of Dams

- Earthfill (about 90 percent)
- **Rockfill**
- Gravity
- Arch
- Masonry
- Concrete

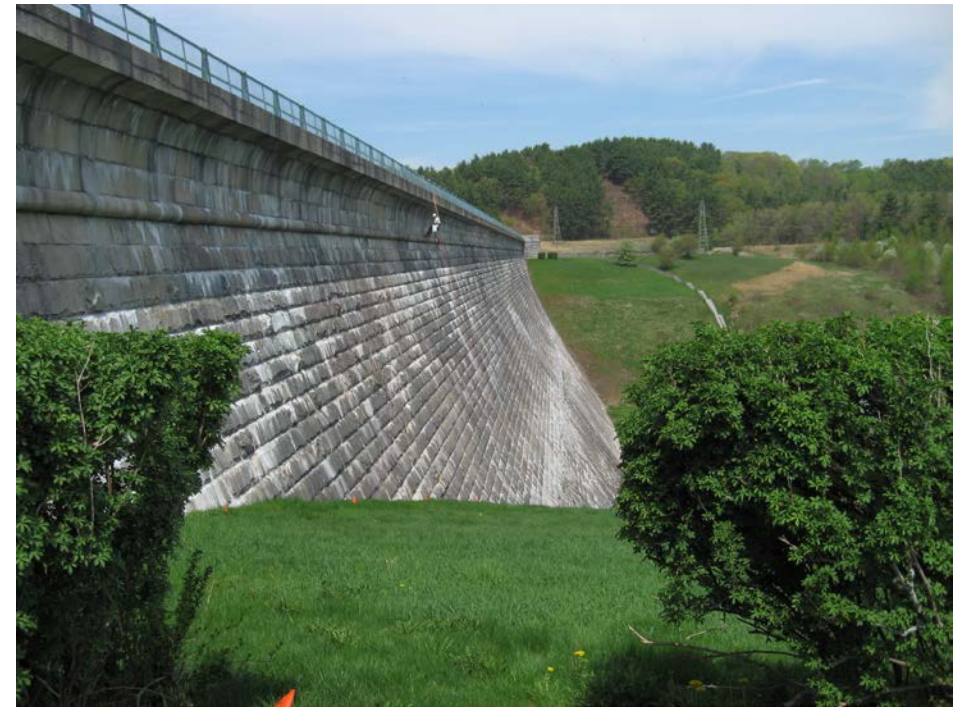
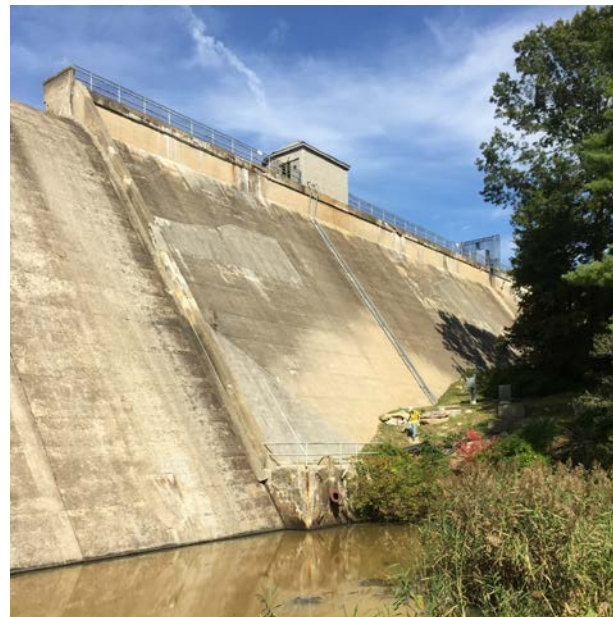
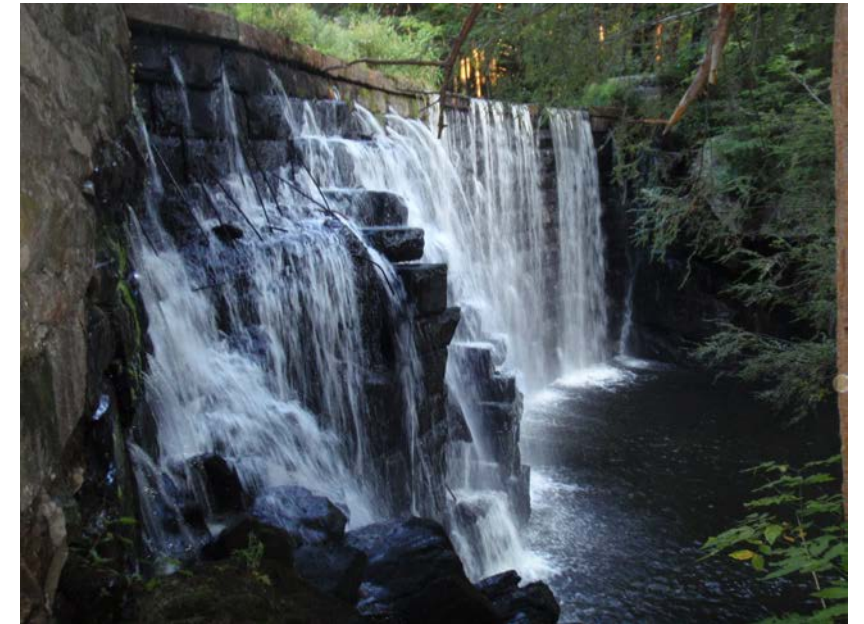
Types of Dams

- Earthfill (about 90 percent)
- Rockfill
- **Gravity**
- Arch
- Masonry
- Concrete
- Roller-Compacted Concrete
- Timber Crib and Other

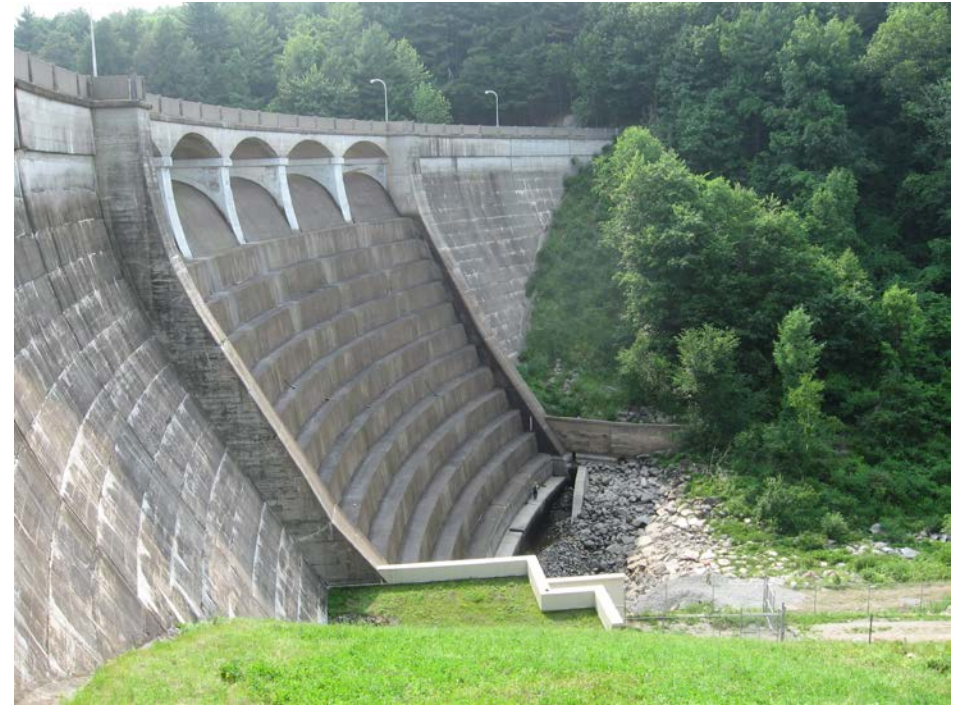
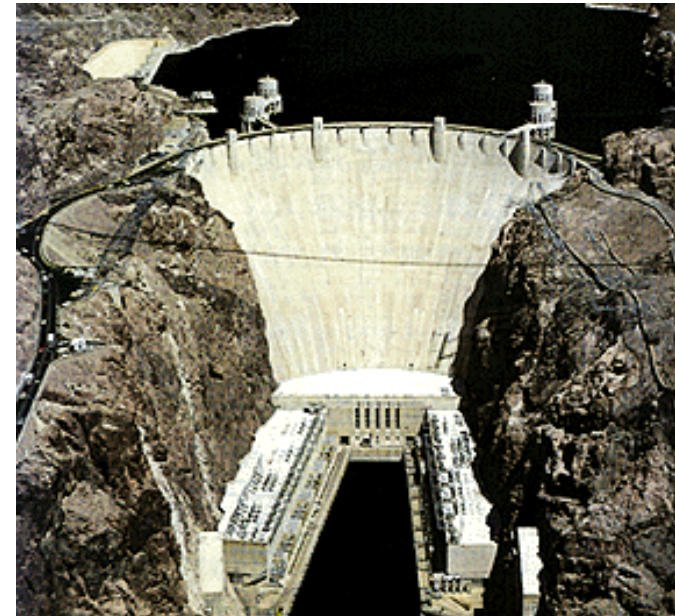
Types of Dams

- Earthfill (about 90 percent)
- Rockfill
- Gravity
- **Arch**
- Masonry
- Concrete
- Roller-Compacted Concrete
- Timber Crib and Other

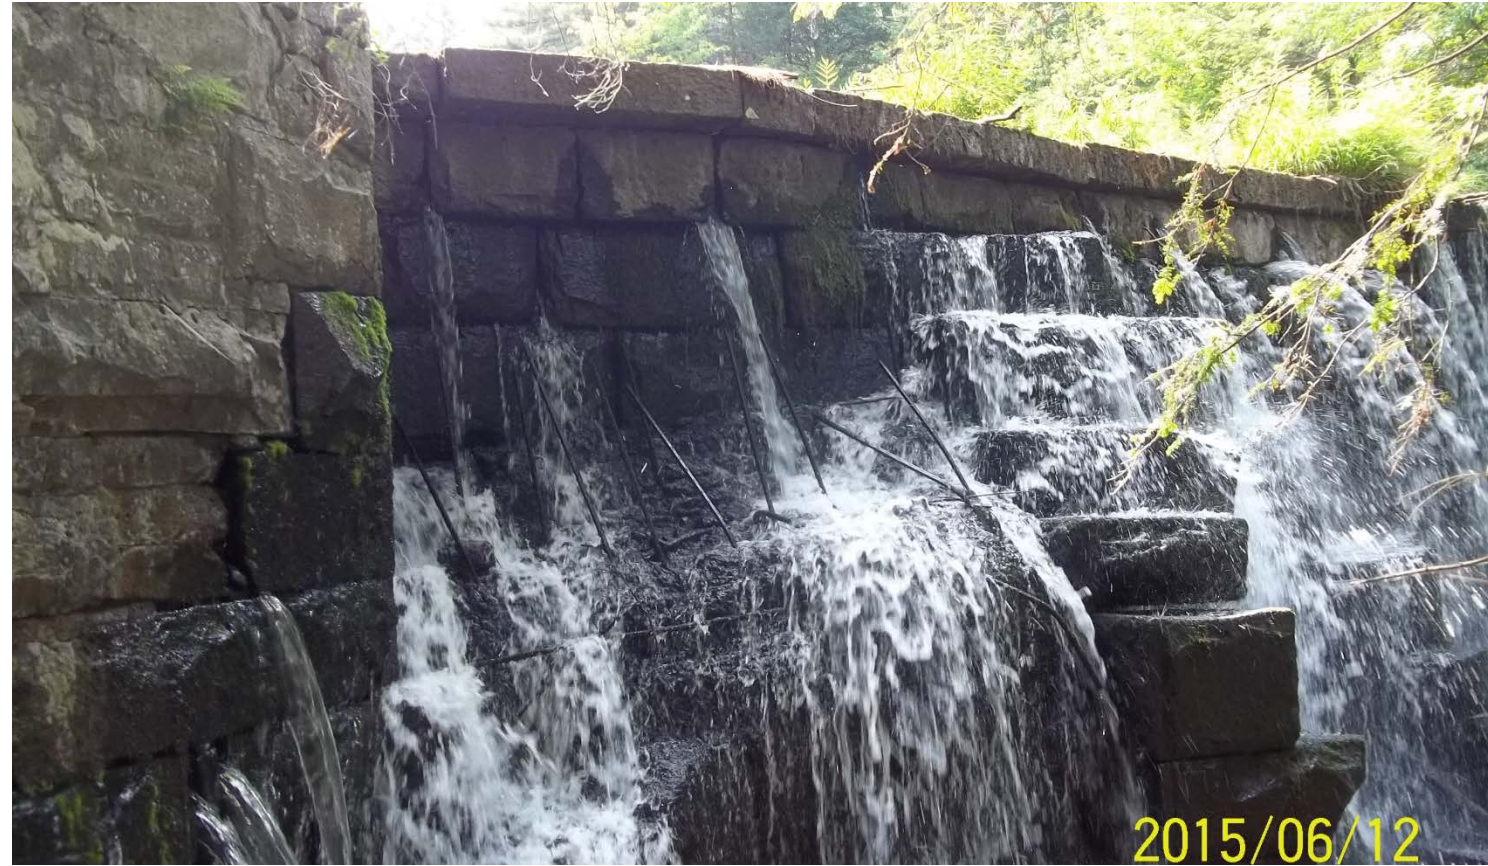
- **No Longer Serving Intended Purpose...Remove it**

- Upper Roberts Meadow Reservoir Dam was constructed in 1883 as a water supply reservoir for City of Northampton
- High Hazard Dam in Poor/Unsafe Condition since 1970's

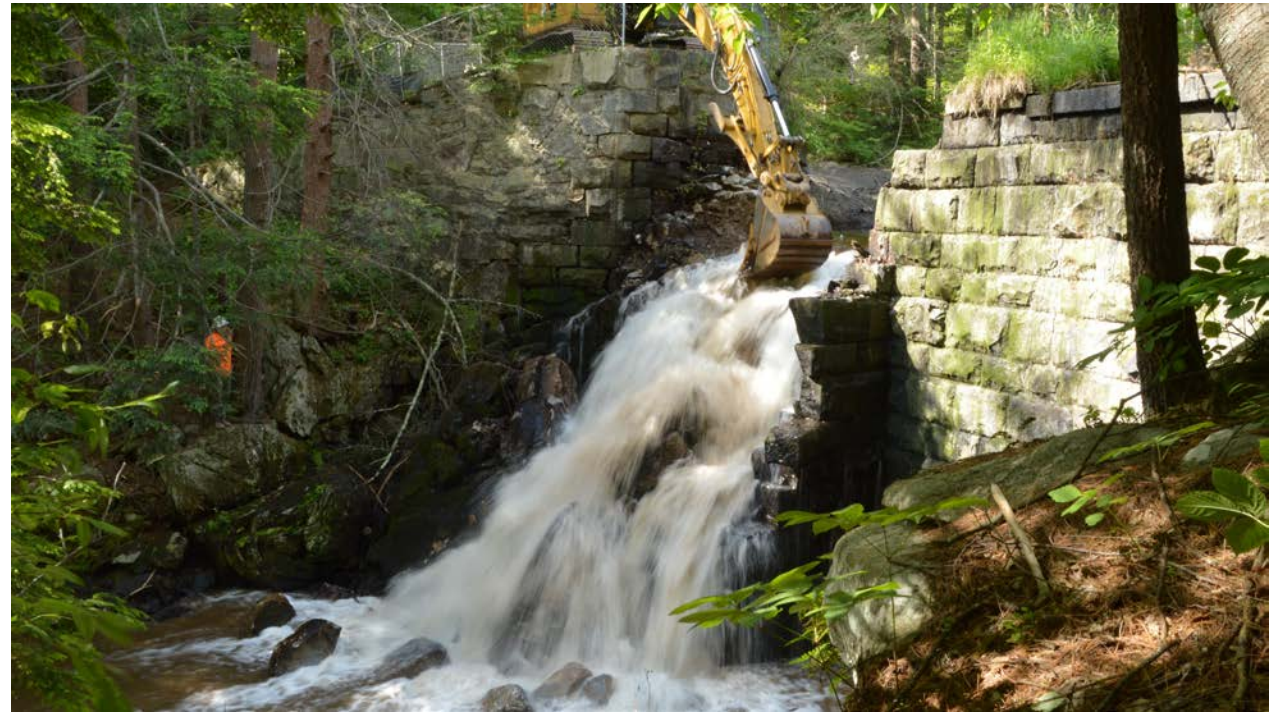
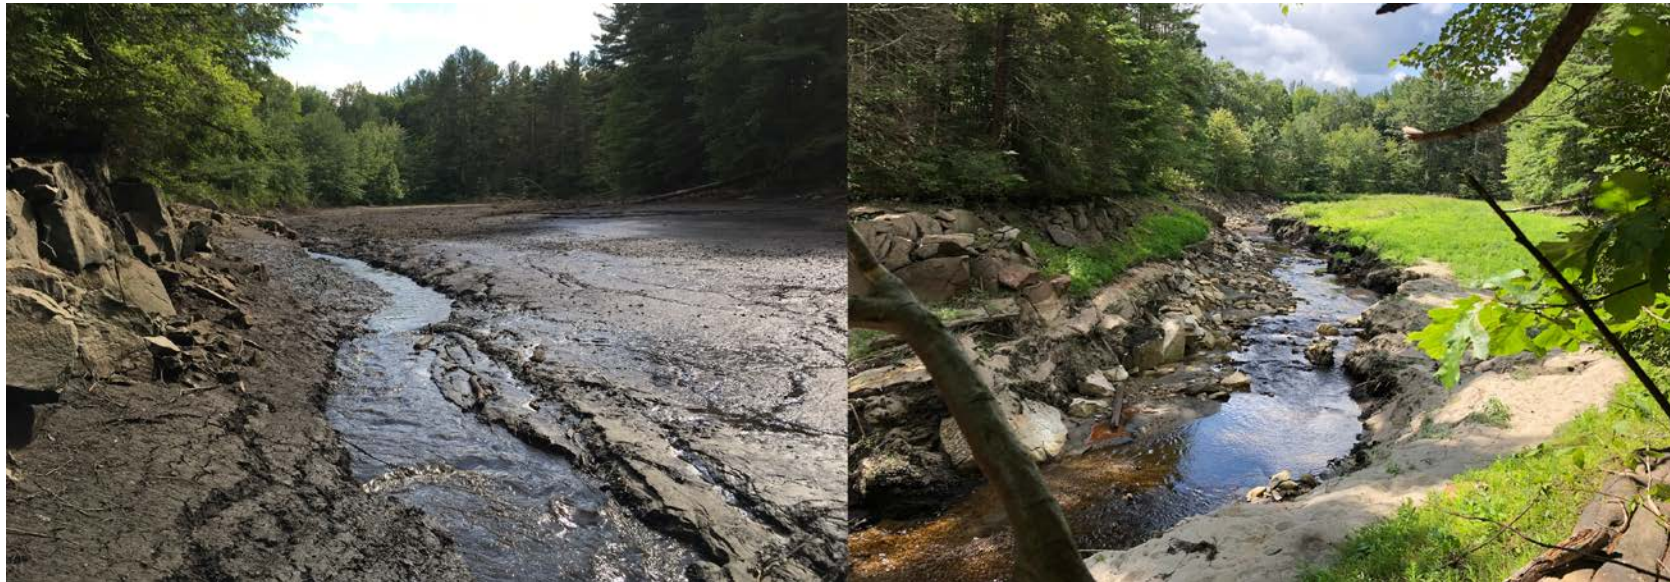
Dam Removal

- Sluice 10,000cyds of sediment using staged dam removal
- Dormant seeds in sediment typically reestablish quickly

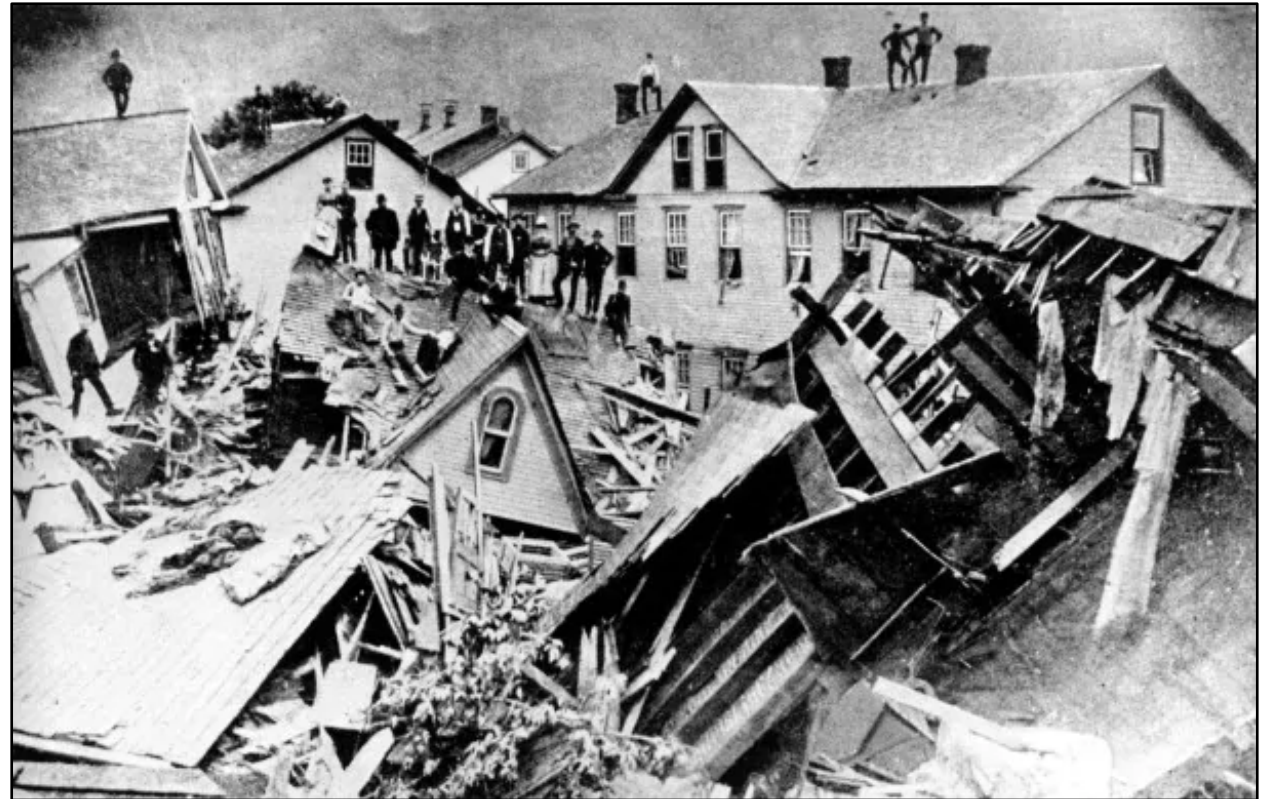
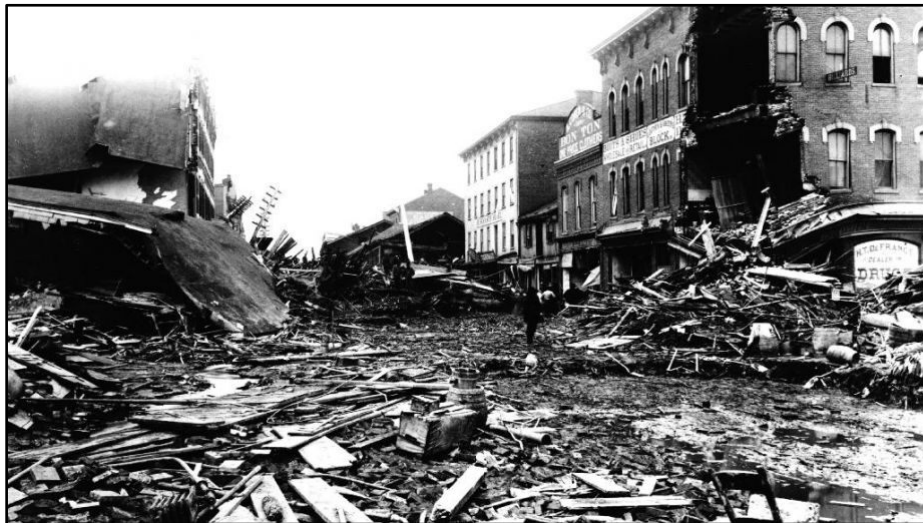
South Fork Dam

Johnstown, PA (1889)

Loss of life 2,200

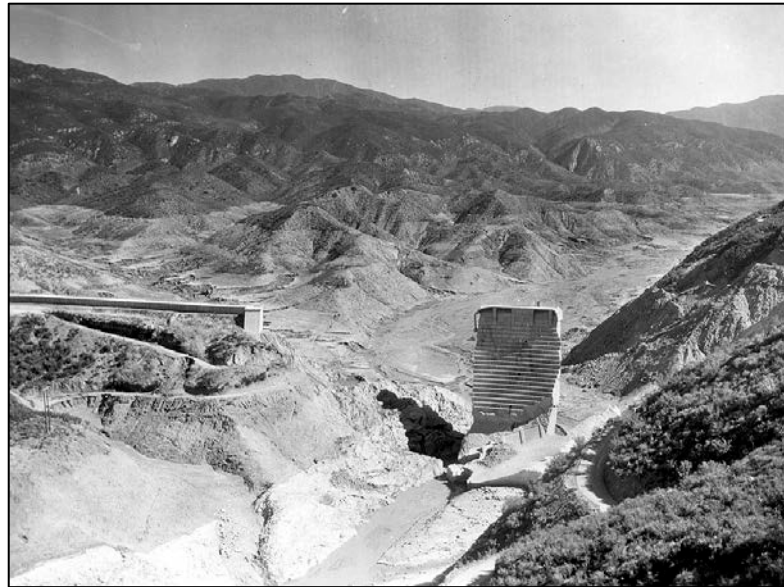
St. Francis Dam, CA (1928)

Loss of life 420

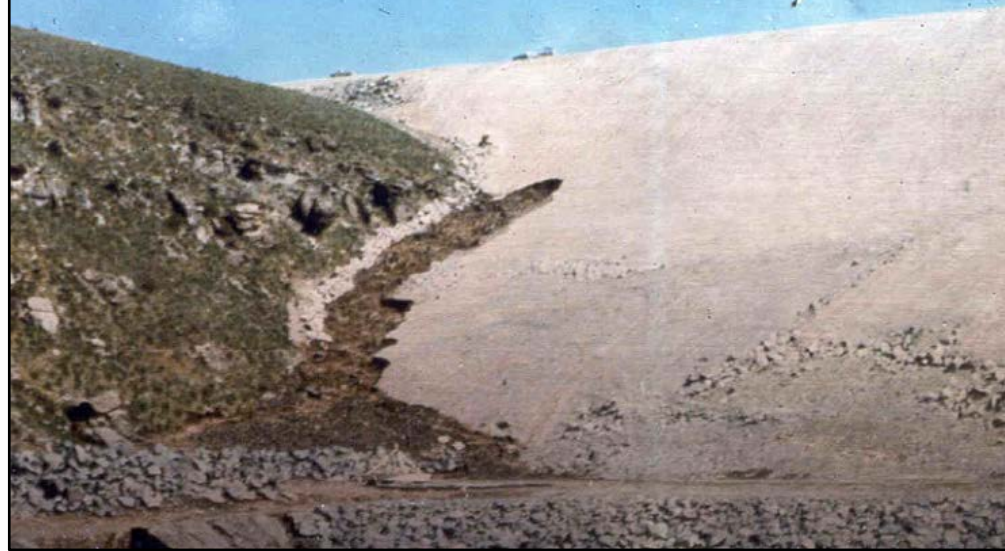
Teton Dam 1976, 11 Fatalities - Initial Filling Internal Erosion

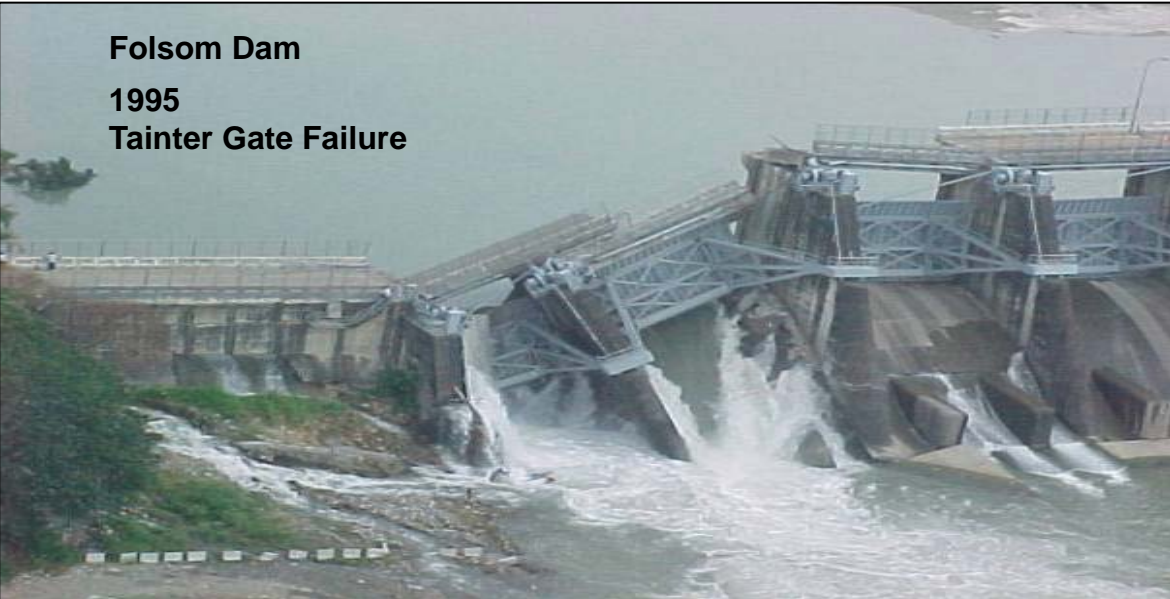
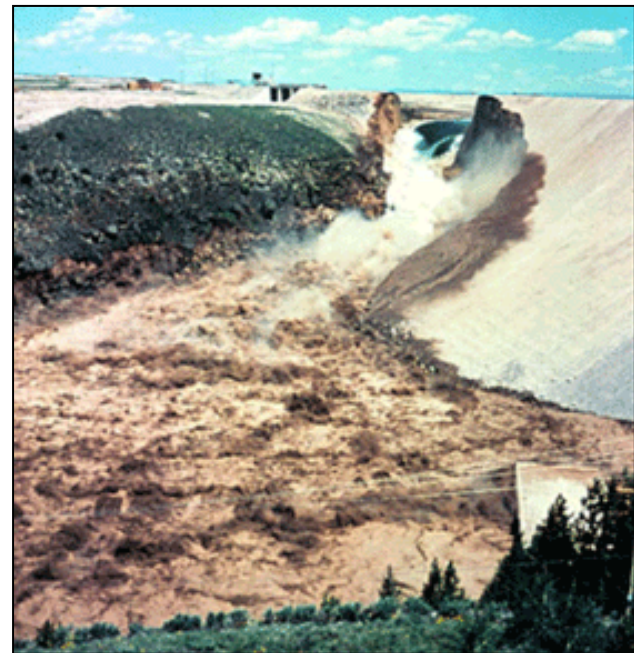
**Folsom Dam
1995
Tainter Gate Failure**

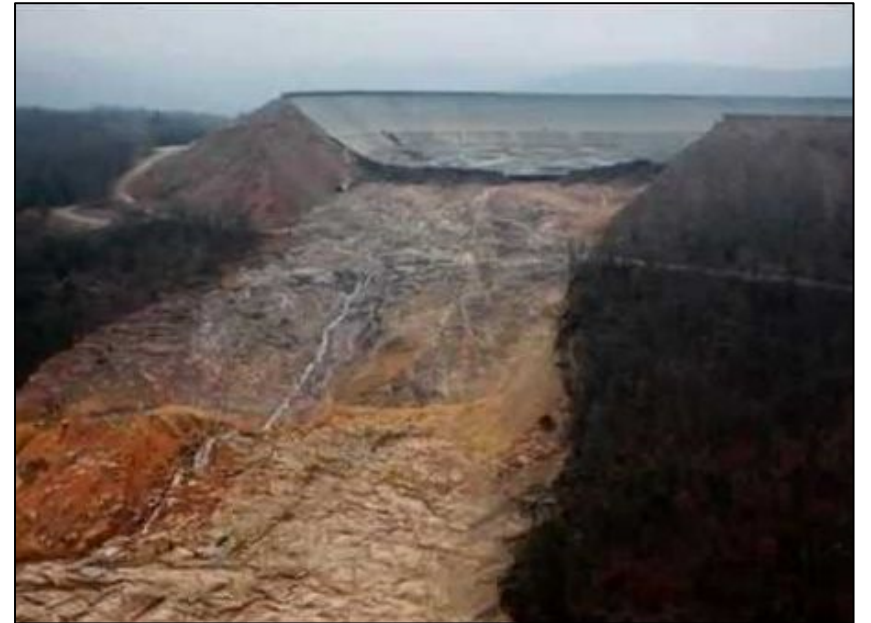
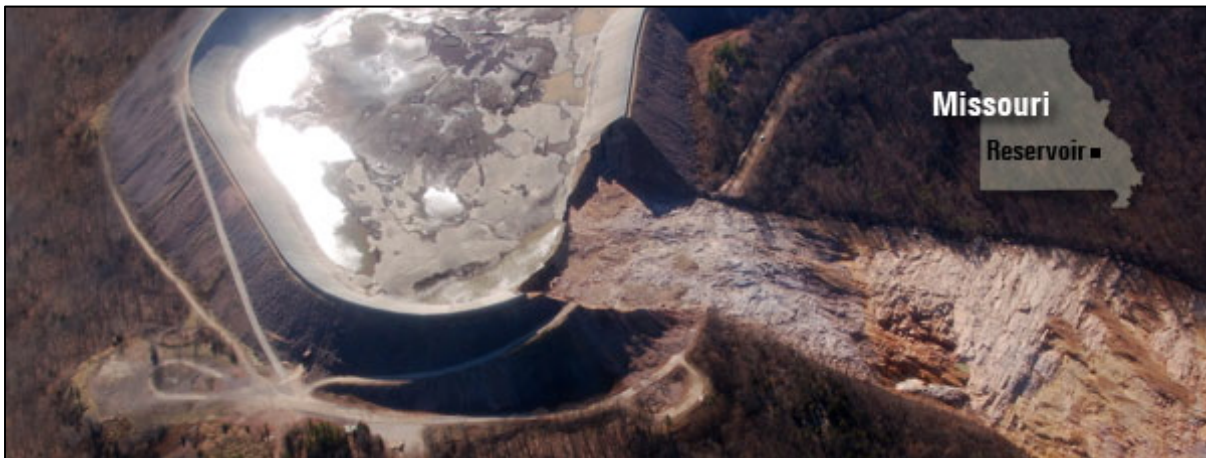
Taum Sauk

2005

Instruments/Overtopping

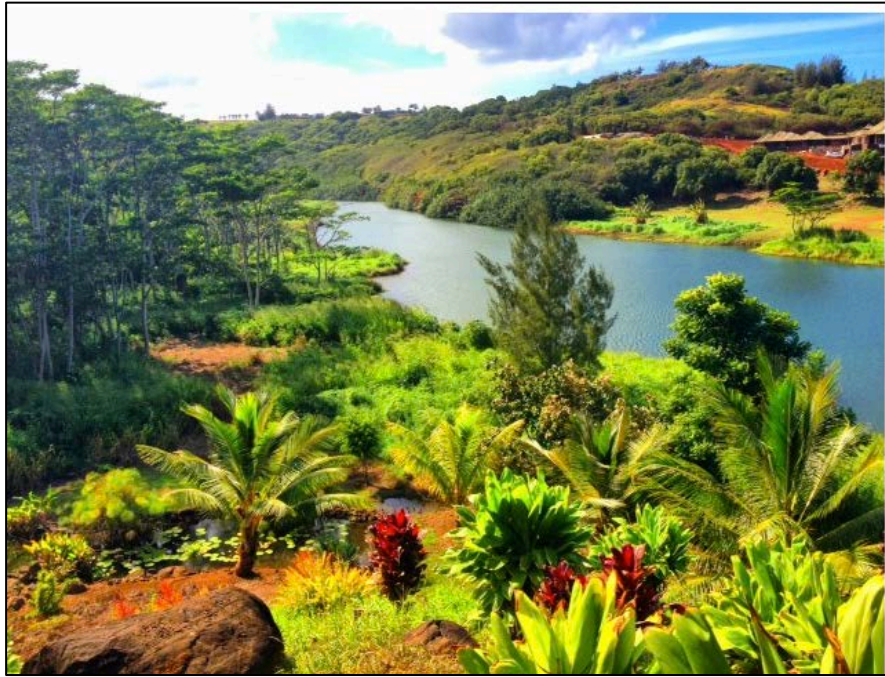
Ka Loko

March 2006

Criminal Charges, 7 dead

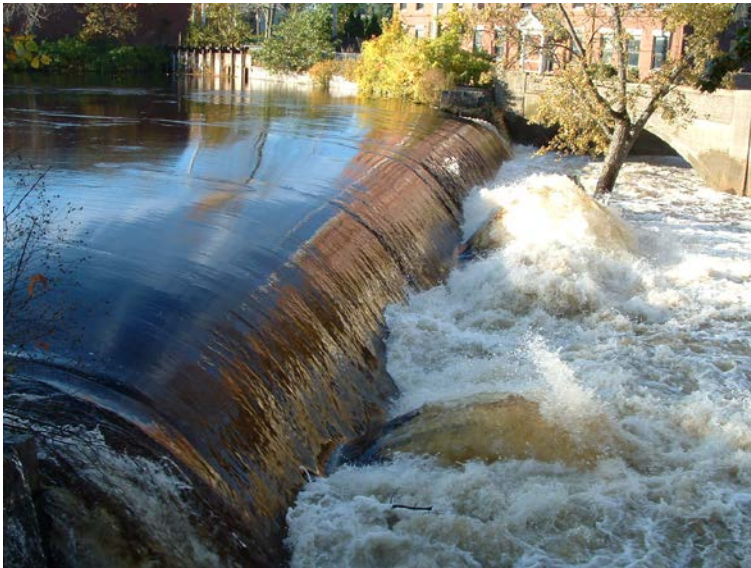
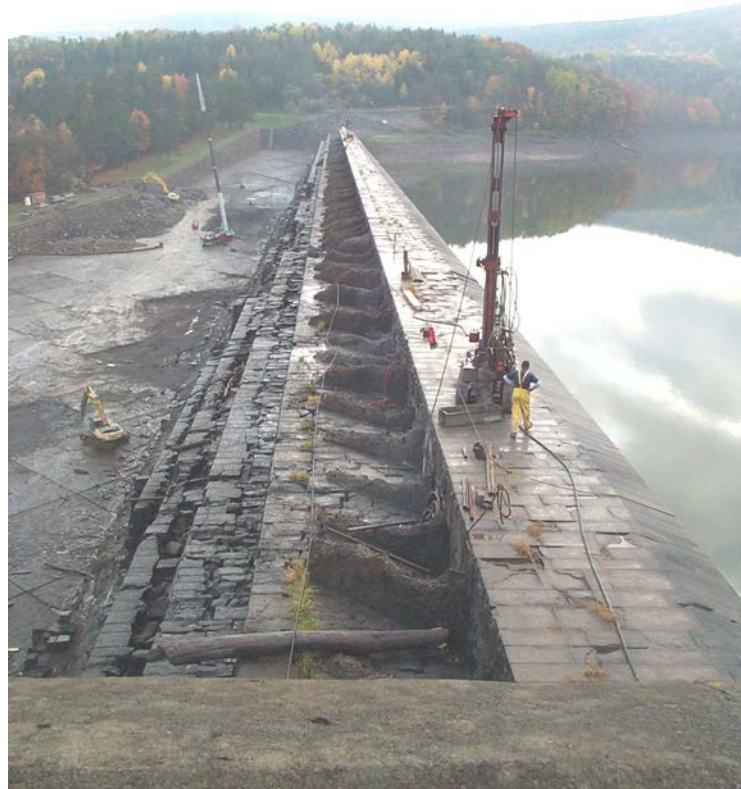
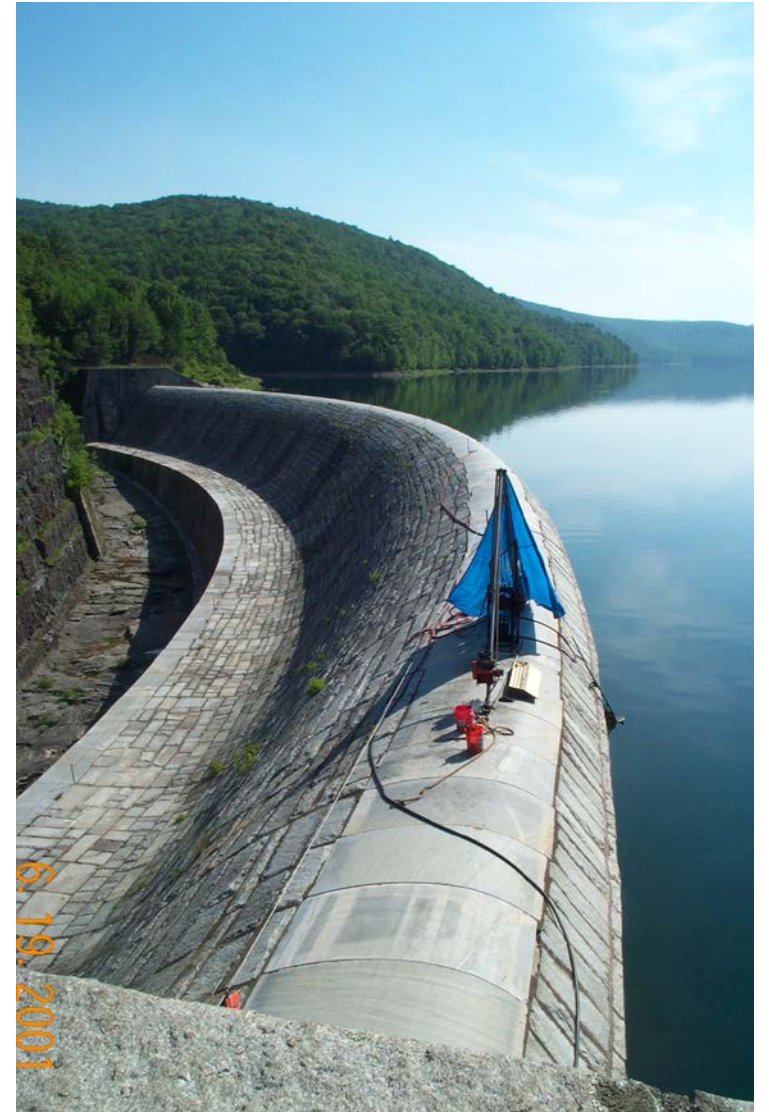
OPTIONS FOR INCREASING SPILLWAY CAPACITY

Hydrologic and Hydraulic Analyses to determine
Outflow for design and capacity of structures

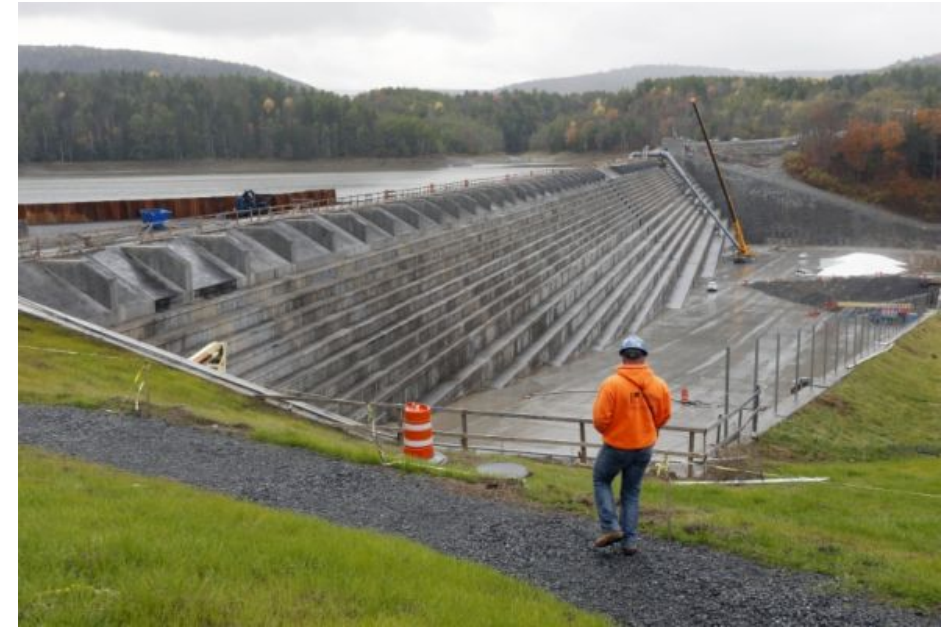
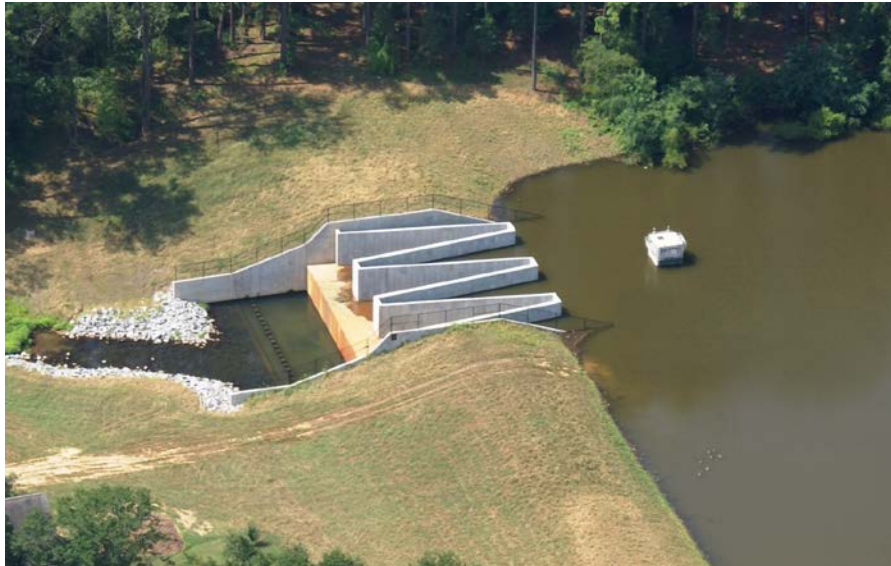
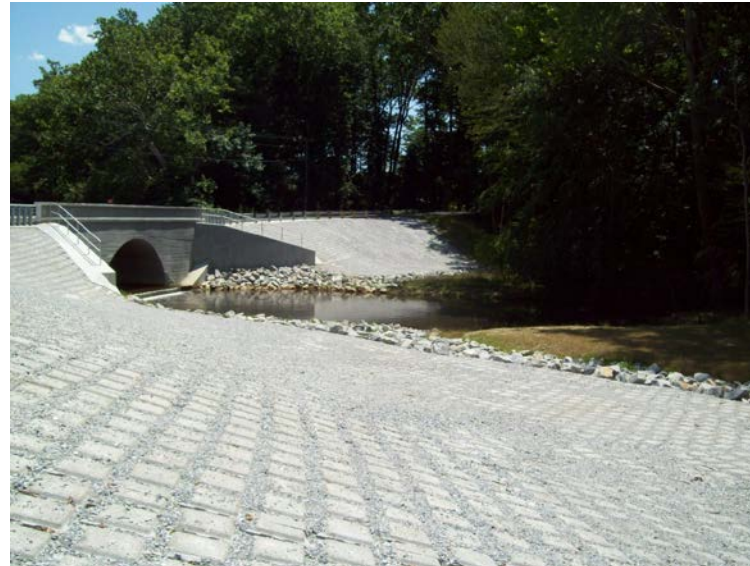
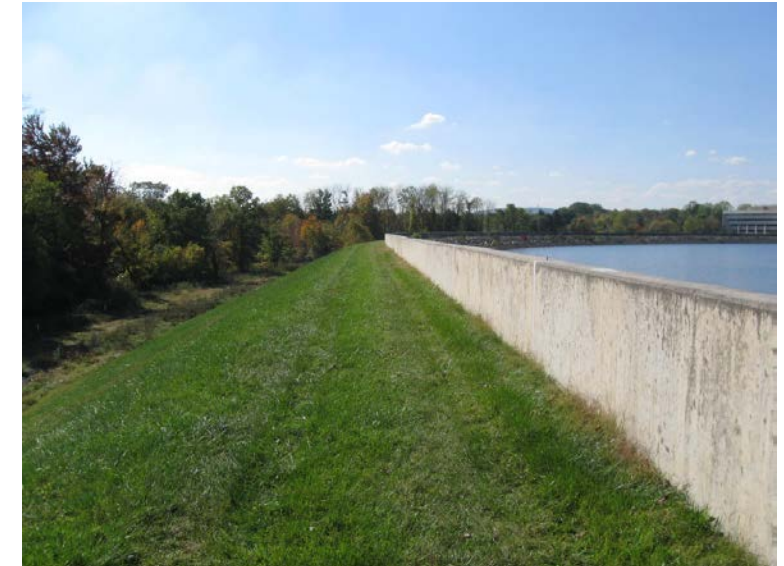
OPTIONS FOR INCREASING SPILLWAY CAPACITY

1. Improve or enlarge existing spillway
2. Construct an auxiliary spillway
3. Raise the dam crest/Lower the lake
4. Protect the dam for overtopping
5. Some combination of options

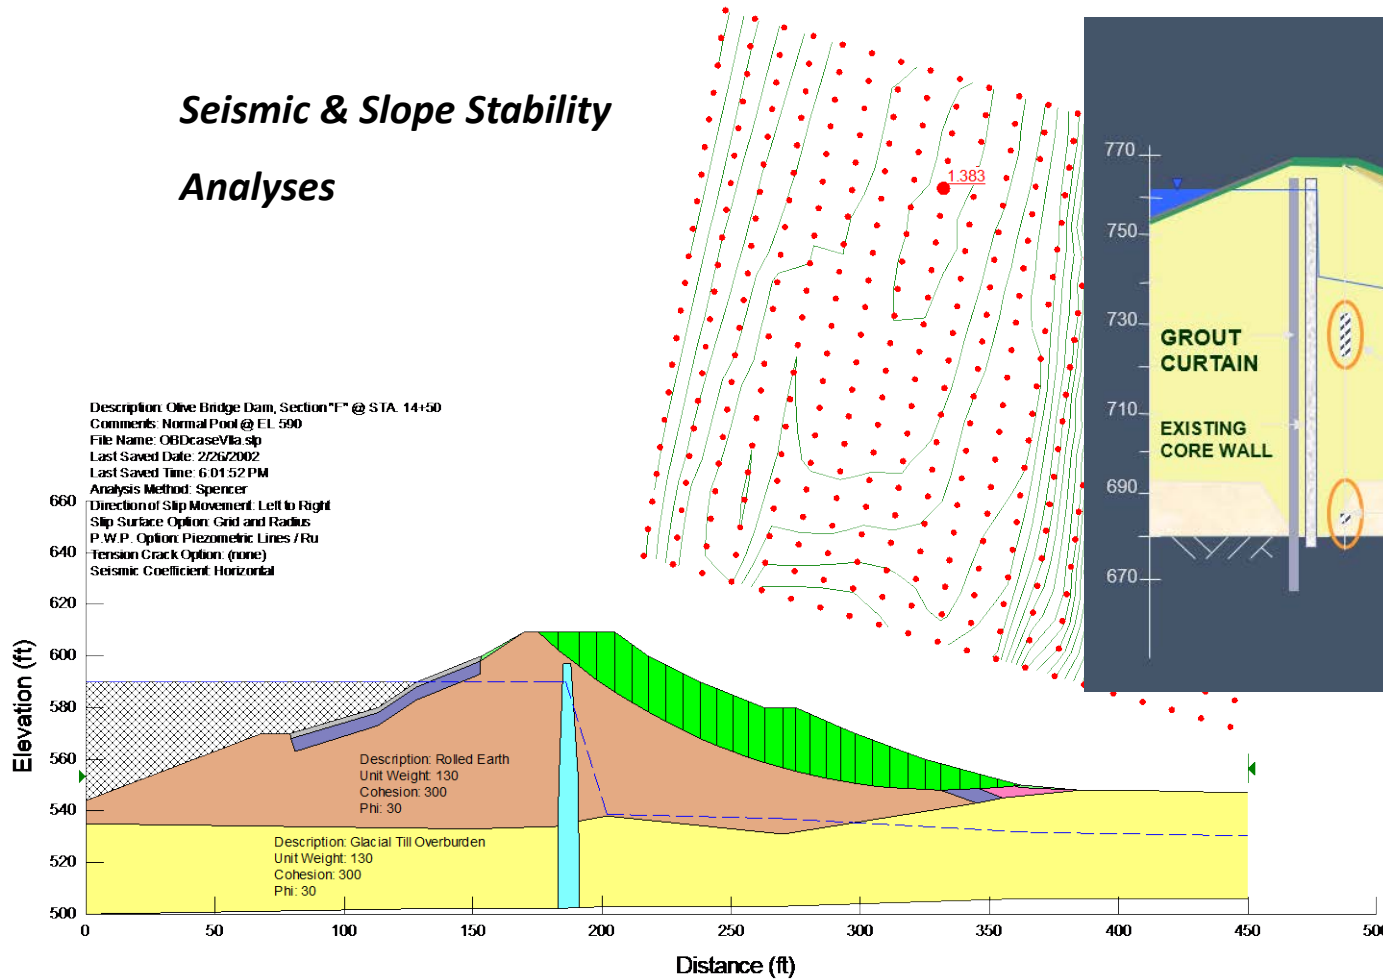
Seismic & Slope Stability Analyses

Embankment Dam Seepage and Stability Analyses and Typical Improvements

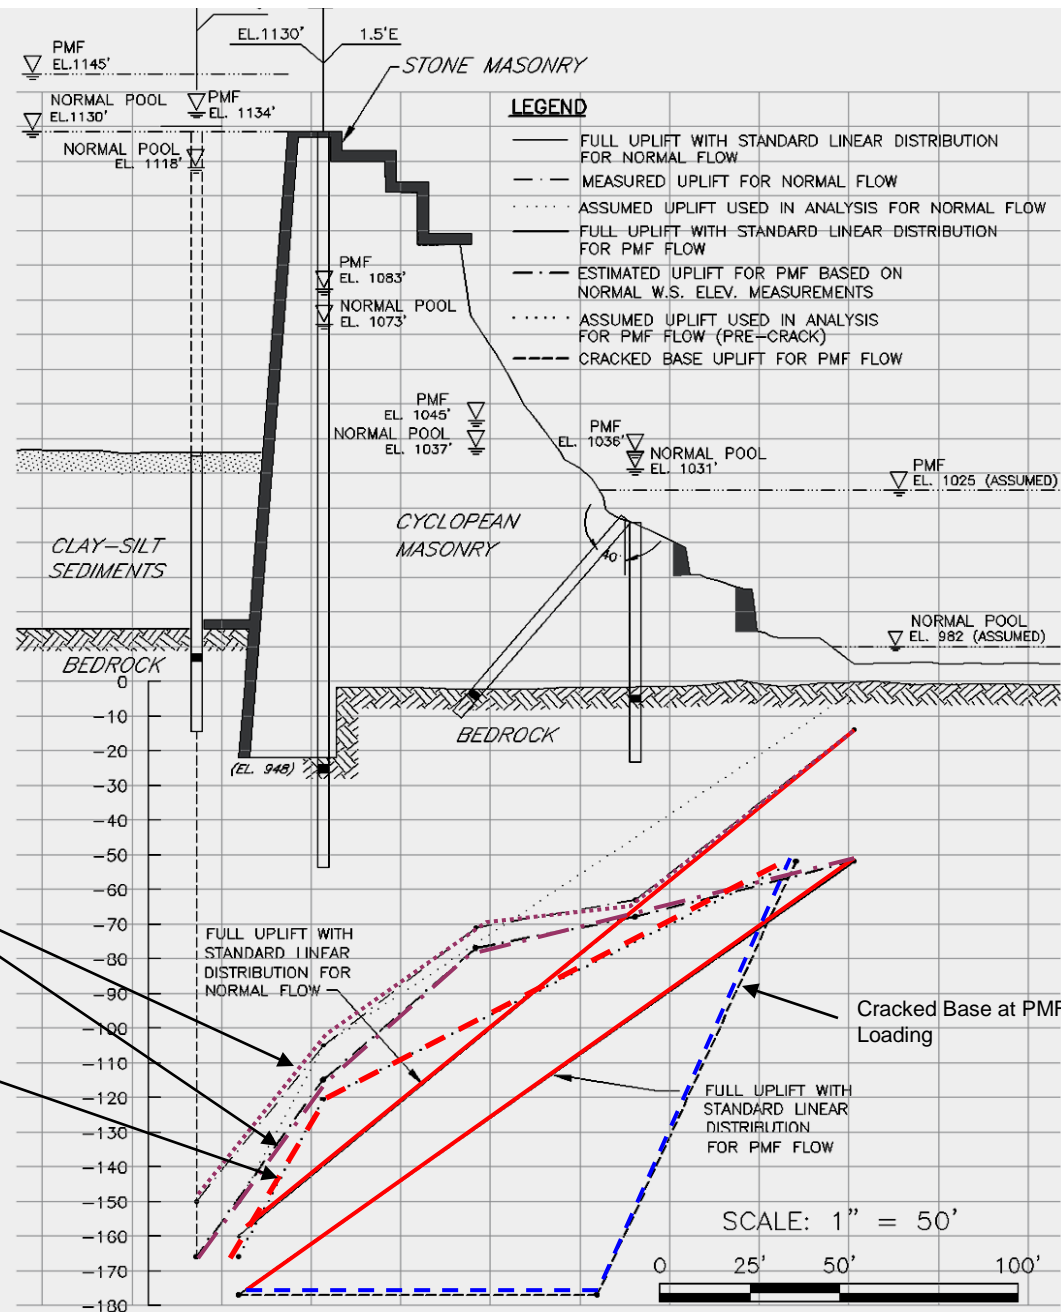
Gravity Section Stability Analysis

Measured Uplift Distribution

Assumed Uplift Distribution for Stability Analysis - Normal Reservoir Level

SCALE: 1" = 50'

Parameter	Material			
	Cyclopean Concrete	Sandstone Bedrock	Shale Bedrock	Concrete / Bedrock Interface
Unit Weight	143 pcf	163 pcf	167 pcf	
Angle of Internal Friction	45°	37°	24° (res.) 35° (peak)	45°
Cohesion/Shear Str.	450 psi	1,000 psi	70 psi	570 psi
Ult. Compressive Str.	4,500 psi	20,000 psi	10,000 psi	
Tensile Strength	180 psi	200 psi	25 psi	25 psi
Modulus of Elasticity	2×10^6	4×10^6	3×10^6	
Poisson's Ratio	0.33	0.78	0.11

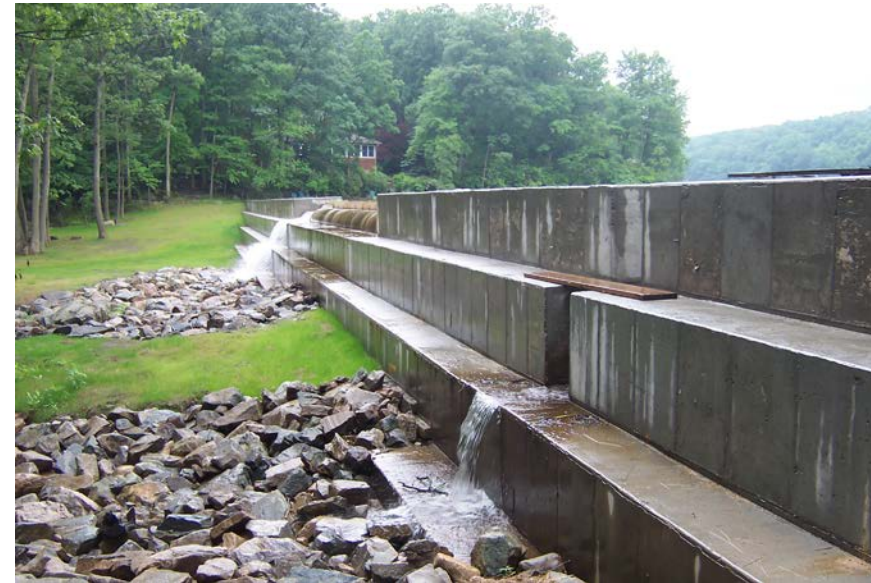
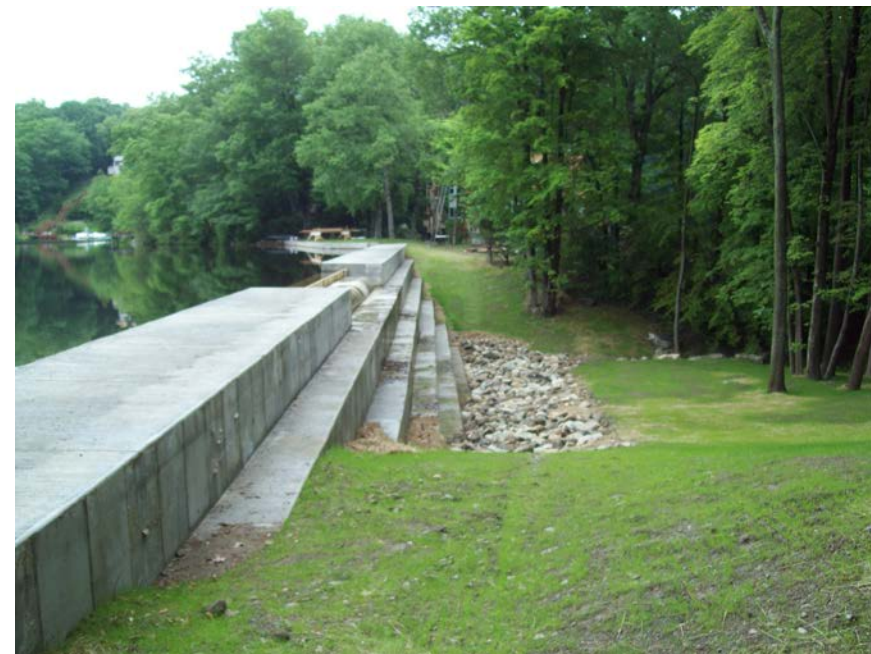
STABILIZATION OF OLD GRAVITY DAMS

Easy Fix - Mass Concrete Buttress!

- Designed to meet stability requirement
- Protects dam during an overtopping event

Other Methods

- Anchors
- Lower Pool

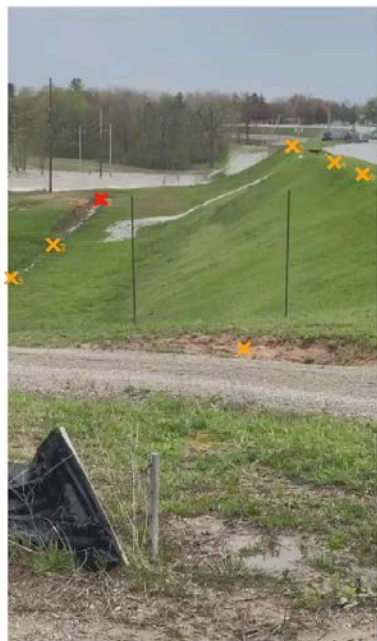
Correlate image pixels with “real-world” dimension using 3D remote sensing DEM data

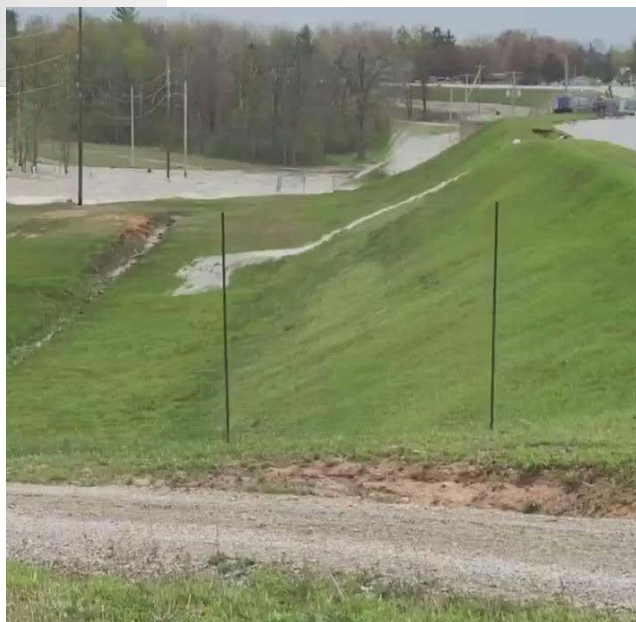
Now we can “read” dam height and length
