Dams and Dam Failures

Anders Bjarngard, P.E. and Yixing Yuan, Ph.D.

Annual Joint Conference
(Virtual)
November 17, 2020

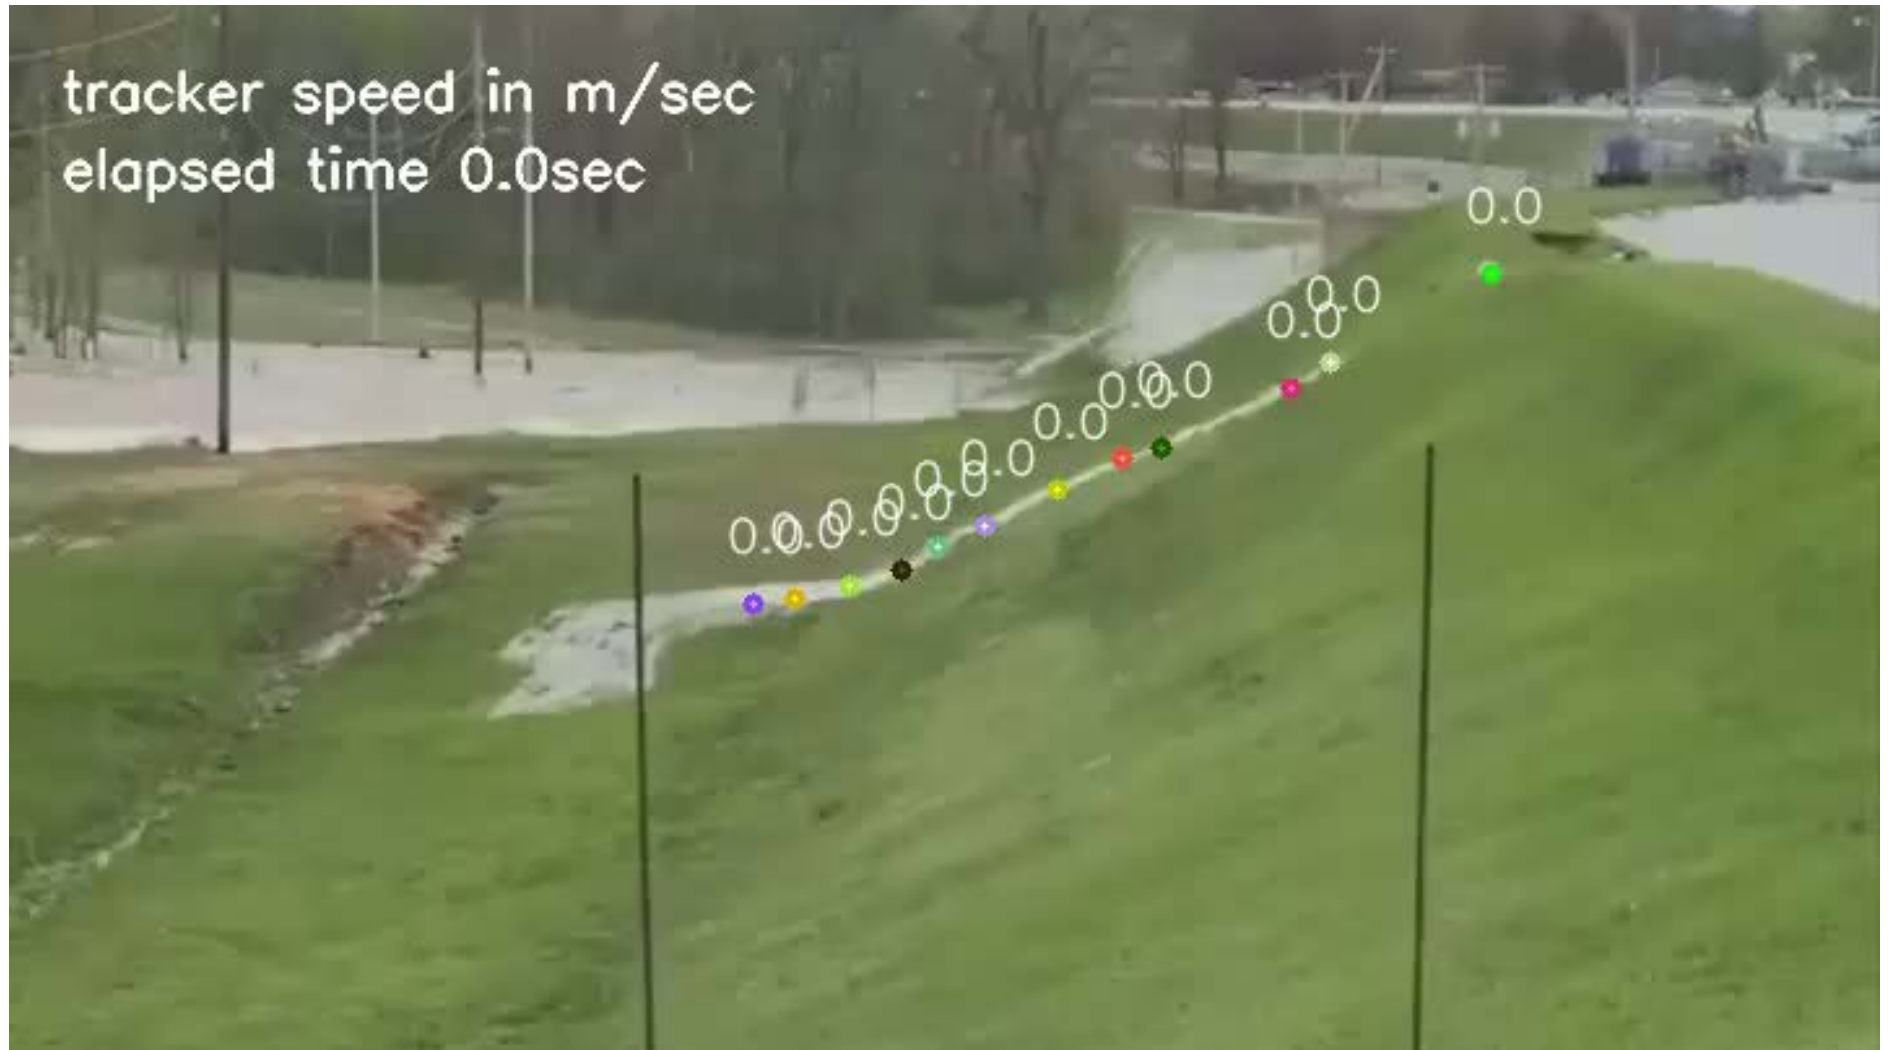
Using optical flow technique to track dam failure motion

Placing a series of pixel tracker on the slope near failure sections, their trajectories highlight dam sliding mechanism

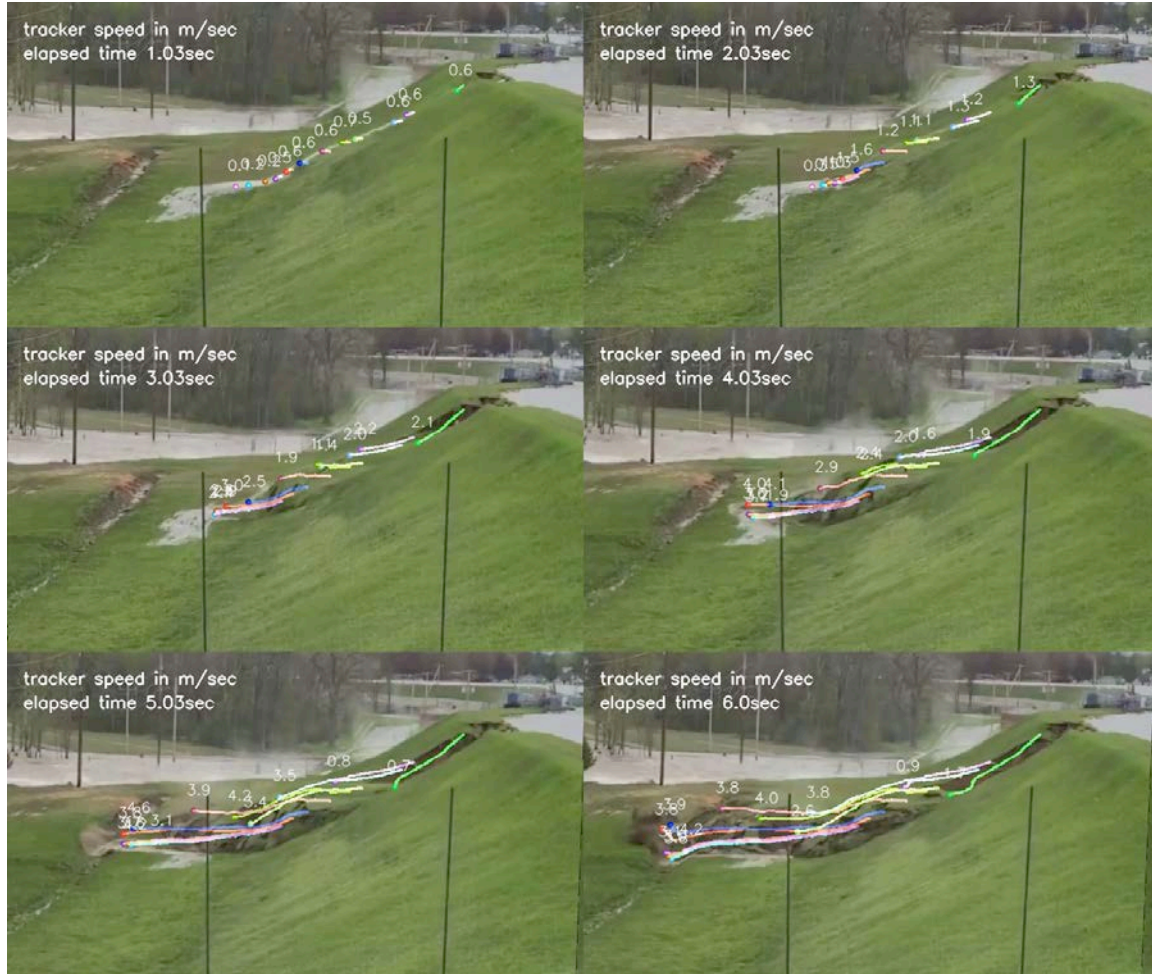
Data extraction and physical attributes analyses

Dam failure undergoes acceleration and deceleration process with max sliding velocity up to 5m/sec (11mph)
